## Case Study:

Napier NA358 Turbocharger

## Investigation into oil leak leads to installation of new cartridge and overhaul to damaged turbocharger

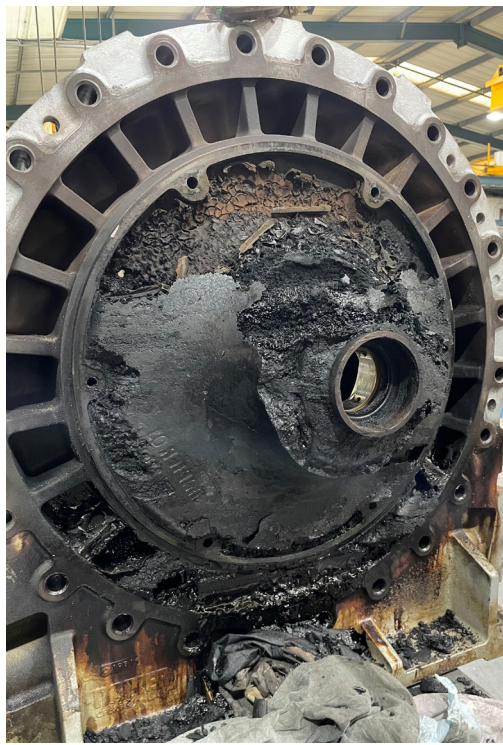
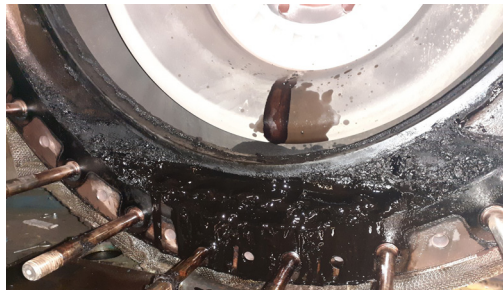
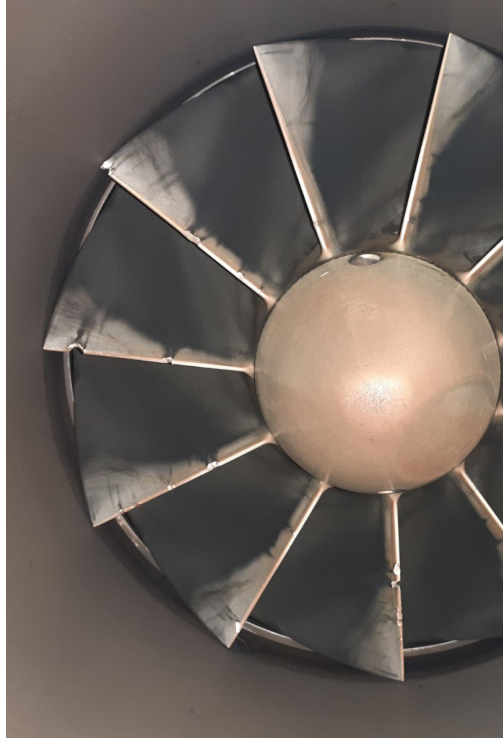
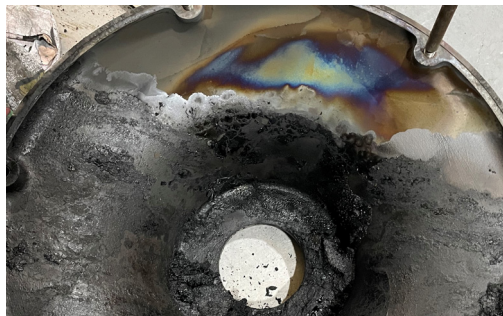
Once on site, after removing the compressor casing there was signs of damage to the impeller and carbon build up from a turbine oil leak preventing air flow through the turbocharger.

After removing the old turbocharger, a new cartridge was fitted with oil pressure checked, clearances assessed, nozzle and shroud fasteners checked and torqued to manufacturers recommendations, engine prelube deisolated and a trial completed.

The defective turbocharger was brought back to Royston's workshop for cleaning and full overhaul.
